Test Report No. 221416313 Rev 01

Performance Test of Partition Wall System using "GEG-ECO Light Weight Panel 105mm (Thickness)" submitted by GE Tech Industry Sdn. Bhd.

The sample was tested in accordance with BS 5234: Part 2: 1992 "Partitions (including matching linings) Part 2. Specification for performance requirements for strength and robustness including methods of test"

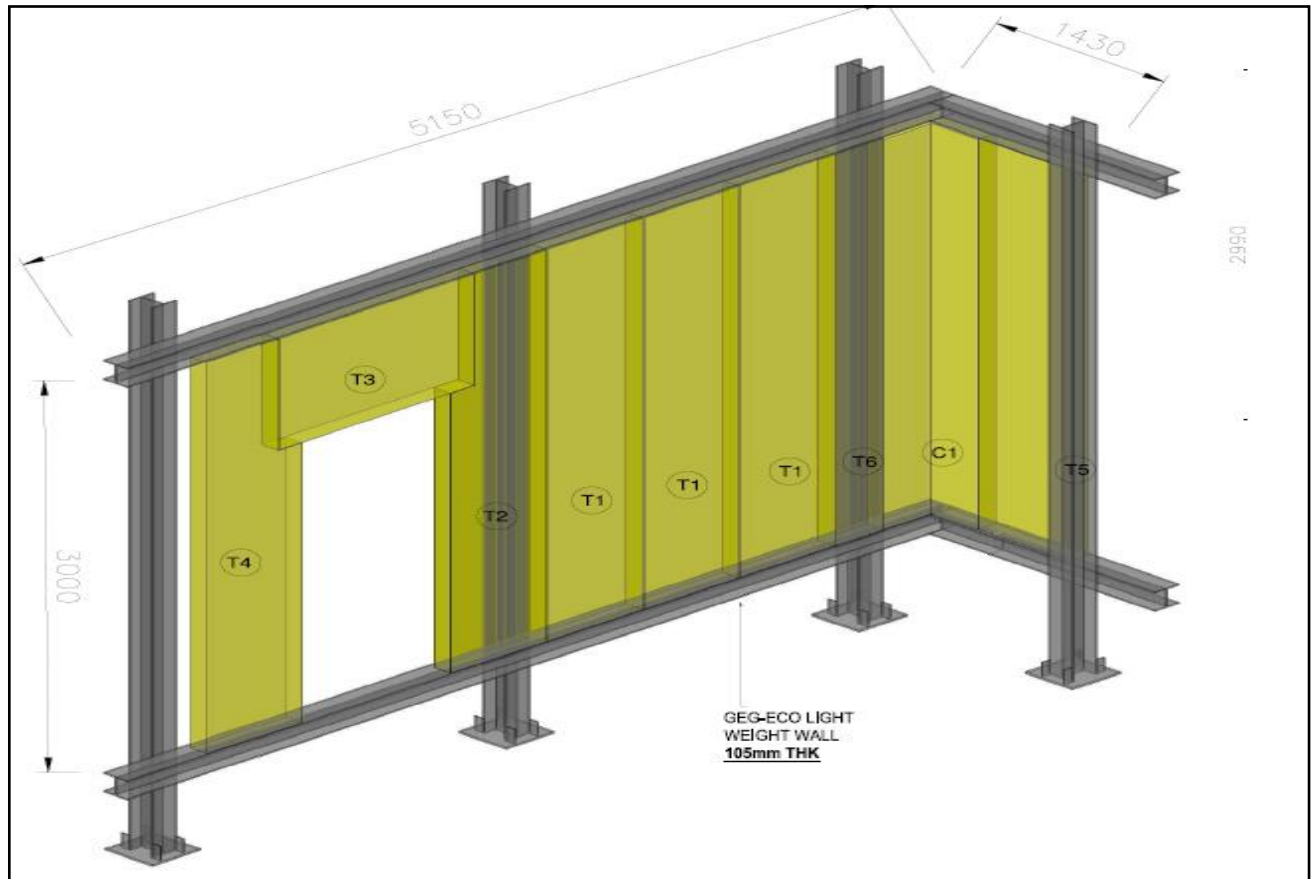
Figure 1: Detail sizes of GEG-ECO Light Weight Panels arrangement installed on the testing's frame.

No.	Width (mm)	Height (mm)	Quantity
T1	600	2990	3 nos
T2	590	2990	1 nos
T3	1220	850	1 nos
T4	600	2990	1 nos
T5	600	2990	1 nos
T6	300	2990	1 nos
C1	405 + 405	2990	1 nos

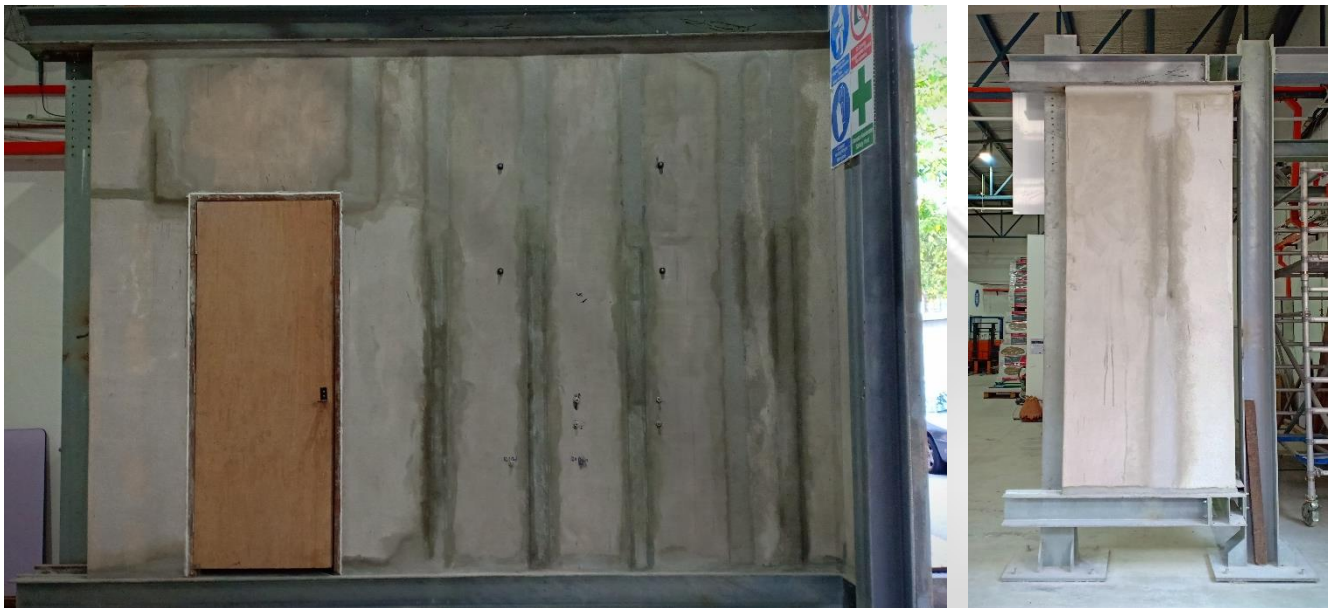
Figure 4: Test mock-up of GEG-ECO Light Weight Panel installed and right corner junction.

A mock-up test specimen 4615mm width X 3000mm height and a partition junction assembly of a right-angle corner with a return of 1005mm was installed onto the test rig for the performance test. Total, 2 sheets of company's drawings contain the details of the mock-up specimen.

The test specimen includes a door set 900mm width X 2100mm height and a 600mm run of partition flanking at one side of the doorset.

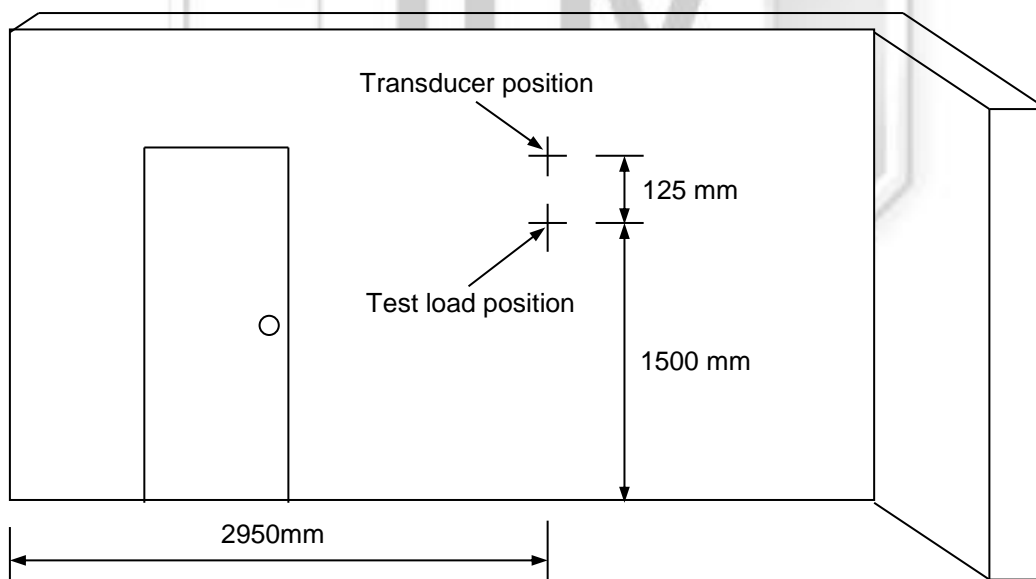
Figure 5: Location of applied load for partition stiffness test

Date of test: 23/4/2019
 Lab temperature / Humidity: 31.2°C / 72%
 Grade tested / load applied: Severe Duty / 500N ± 15 N

Load (N)	Duration (min)	Deflection (mm)	Residual Deflection (mm)	Condition of the specimen tested	BS 5234: Part 2: 1992 Requirements
Pretest load of 100 N	1	0.00	0.00		1) There shall be no damage or detachment, loosening or dislodgement of partition wall's parts or fixing
100	2	0.00	-	Passed (No damage occurred)	2) The Maximum deflection and residual deformation shall not exceed 10 & 1 mm respectively.
200	2	0.00	-		
300	2	0.00	-		
400	2	0.00	-		
500	2	0.00	0.00

A static horizontal load of 500 N (± 15 N) was applied through a 150 mm (± 1 mm) diameter steel plate with a contact rubber pad of 6 mm (± 2 mm) thick. The load was applied to the partition at a height of 1500 mm (± 10 mm) from the bottom of the setup. Deflection was taken on the load side at 125 mm above the centre point of load application. A pretest load of 100 N was applied and stabilized for 1 min before unloading. The load was then applied in steps of 100 N until 500 N before unloading. Each loading was maintained for about 2 minutes for stabilization.

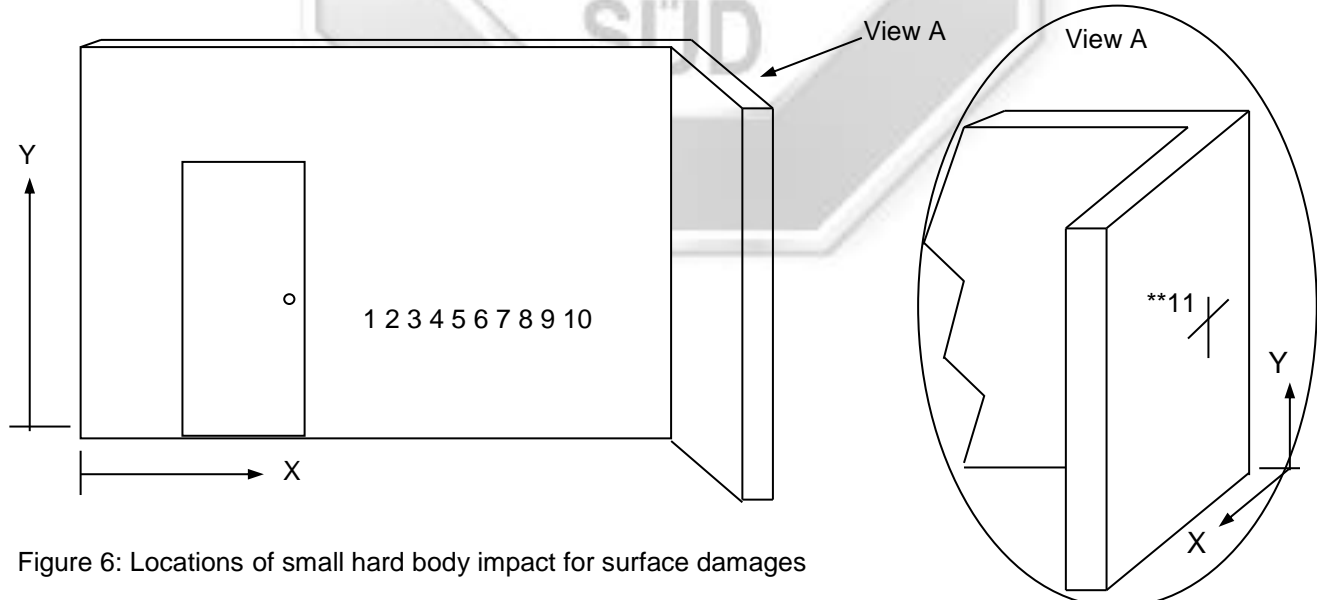
Figure 6: Locations of small hard body impact for surface damages

Impact Position	X (mm)	Y (mm)	Depth of indentation (mm)	Condition of the specimen tested	BS 5234: Pt 2: 1992 Requirements
1	1775	760	1.61	Tested 1) No detachment, loosening or dislodgement of its parts or fixings occurred. 2) See Fig. 6 photos for over view of surface damage.	1) No specific criterion for acceptance 2) Attached photographs of surface damages for the authority judgement to be made whether can be easily repaired for acceptance
2	1875	760	1.08		
3	1975	760	0.71		
4	2075	760	0.46		
5	2175	760	0.80		
6	2275	760	0.83		
7	2375	760	0.66		
8	2475	760	0.56		
9	2575	760	0.59		
10	2675	760	0.75		
**11	75	1100	1.11

10 positions on the main wall of the test setup were chosen for the test. Each position was subject to a 10 Nm impact energy. The swinging arm was raised by 0.33 m or an angle of 63.6 degree and released. The rebound of the steel arm was withheld to prevent it from making a second impact.

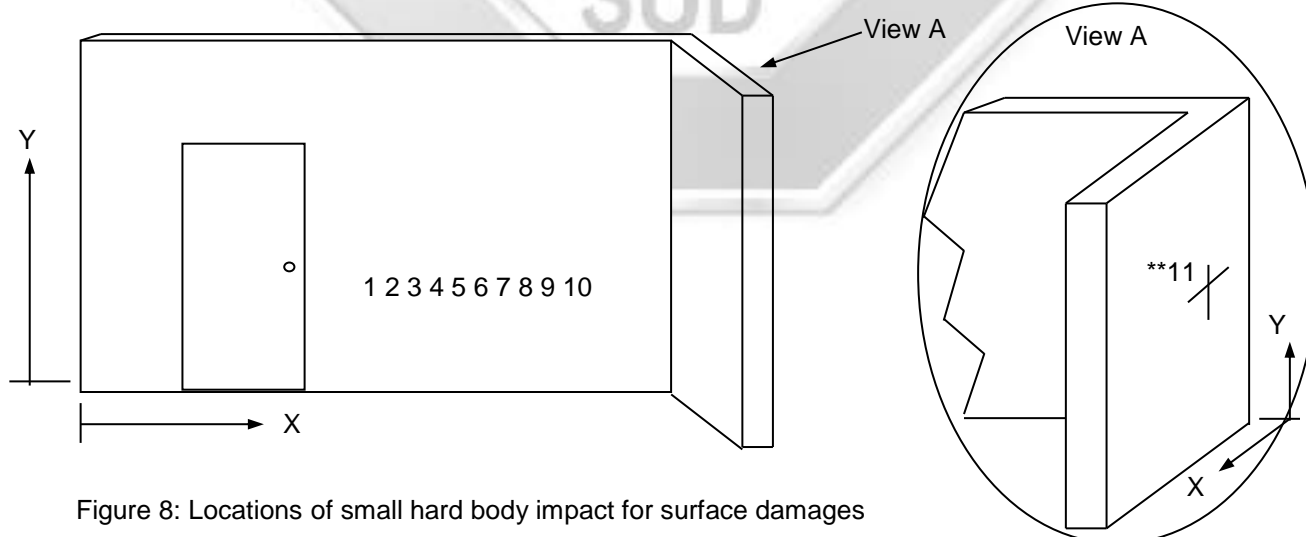
Figure 8: Locations of small hard body impact for surface damages

Impact Position	X (mm)	Y (mm)	Depth of indentation (mm)	Condition of the specimen tested	BS 5234: Pt 2: 1992 Requirements
1	3030	760	2.35	Tested 1) No detachment, loosening or dislodgement of its parts or fixings occurred. 2) See Fig. photos for over view of surface damage.	1) No specific criterion for acceptance 2) Attached photographs of surface damages for the authority judgement to be made whether can be easily repaired for acceptance
2	3130	760	2.91		
3	3230	760	2.52		
4	3330	760	2.62		
5	3430	760	2.51		
6	3530	760	2.70		
7	3630	760	1.97		
8	3730	760	1.78		
9	3830	760	1.95		
10	3930	760	2.00		
**11	75	1200	1.63

10 positions on the main wall of the test setup were chosen for the test. Each position was subject to a 30 Nm impact energy. The swinging arm was raised by 1.0 m or 131.8 degree and released. The re-bounce of the steel arm was withheld to prevent it from making a second impact. The partition was inspected for any damage or perforation.

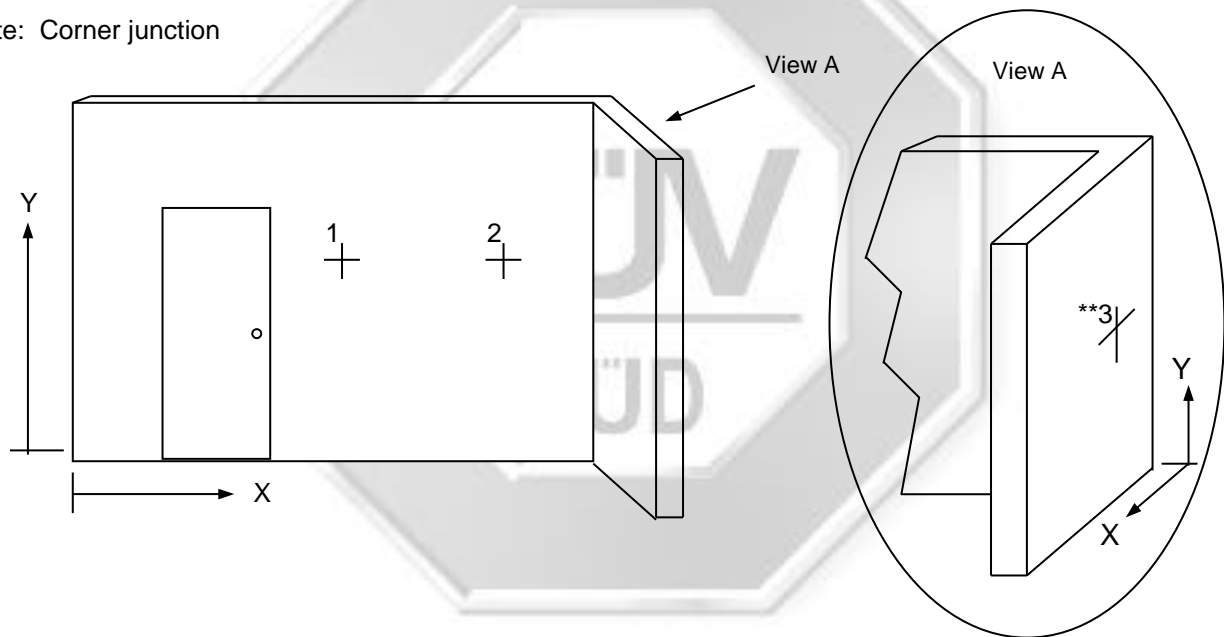
Figure 10: Locations of large soft body impact for resistance to damage

Impact Position	X (mm)	Y (mm)	Residual deflection (mm)	Condition of the specimen tested	BS 5234: Pt 2: 1992 Requirements
1	2500	1480	0.82	Passed (No damage occurred)	The partition wall and a right angle junction shall be capable of withstanding the impact energies without sustaining either permanent deformation in excess of 2 mm or any damage.
2	3070	1480	0.06		
**3	200	1480	0.03

Two positions on the partition wall were selected for the test. Each location was subject to a single swinging impact. A linear gauge was placed behind the impacted panel to measure the permanent deformation.

The impact energy was 100 Nm. The impactor was raised by 204 mm before releasing. Permanent deformation was taken after 5 minutes from the impact.

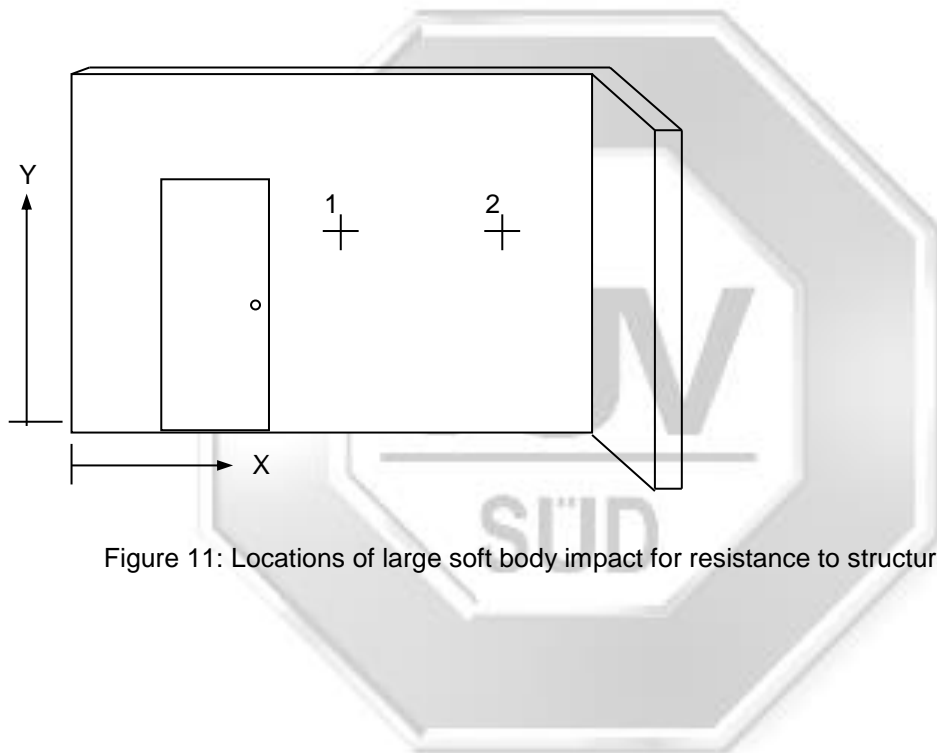
Figure 11: Locations of large soft body impact for resistance to structural damage

Impact Position	X (mm)	Y (mm)	Condition of the specimen tested	BS 5234: Pt 2: 1992 Requirements
1	2750	1480	Passed (No damage occurred)	The partition wall shall be capable of withstanding the impact energies, without collapsing or dislocating the partition wall or its fixings.
2	3050	1480

Two positions on the partition wall were selected for the test. Each location was subject to three swinging impacts.

The impact energy was 120 Nm. The impactor was raised by 245 mm before releasing. The partition was inspected for any surface or structural damage.

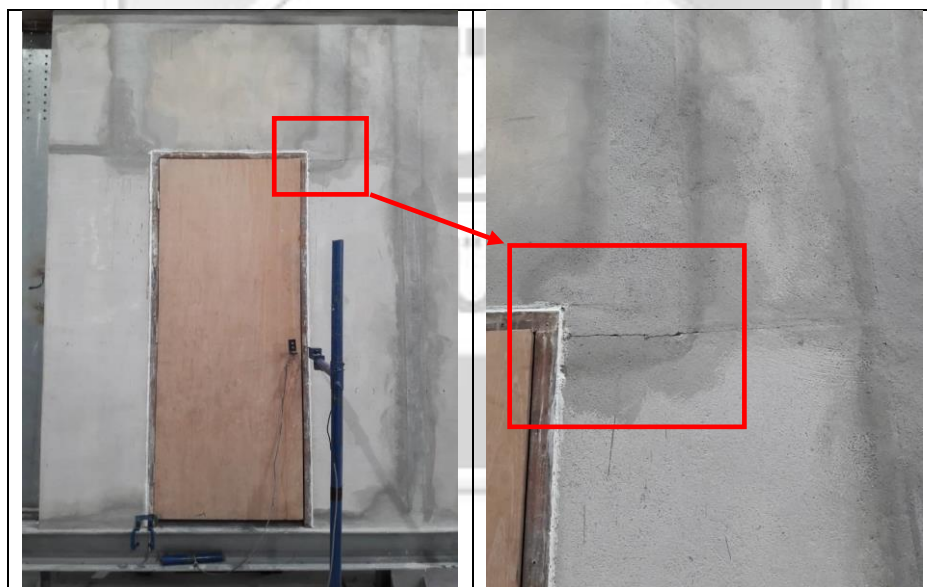
Figure 12: Hair line crack observed at plastering area on top right edge of the door during door slamming test

Number of slam (Open door to 60 ±10°)	Residual deflection (mm)	Condition of the specimen tested	BS 5234: Pt 2: 1992 Requirements
Pretest of 3	0.73	Hair line crack is observed at plastering area on top right edge of the door. (Refer to Figure 12)	1) The partition shall not be damaged, nor shall door frame fittings and architraves become detached or loose after the door leaf has been slammed.
20	0.08		2) The closing jamb of the door frame shall not be permanently displaced by more than 3mm as a result of the pre-slam test and by more than 1 mm as a result of the main slam test, from its position at the start of the test, measured at 1.0m above the bottom of the door leaf.
100	0.38

However, hair line crack was observed at plastering area on top right edge of door during the door slamming test.

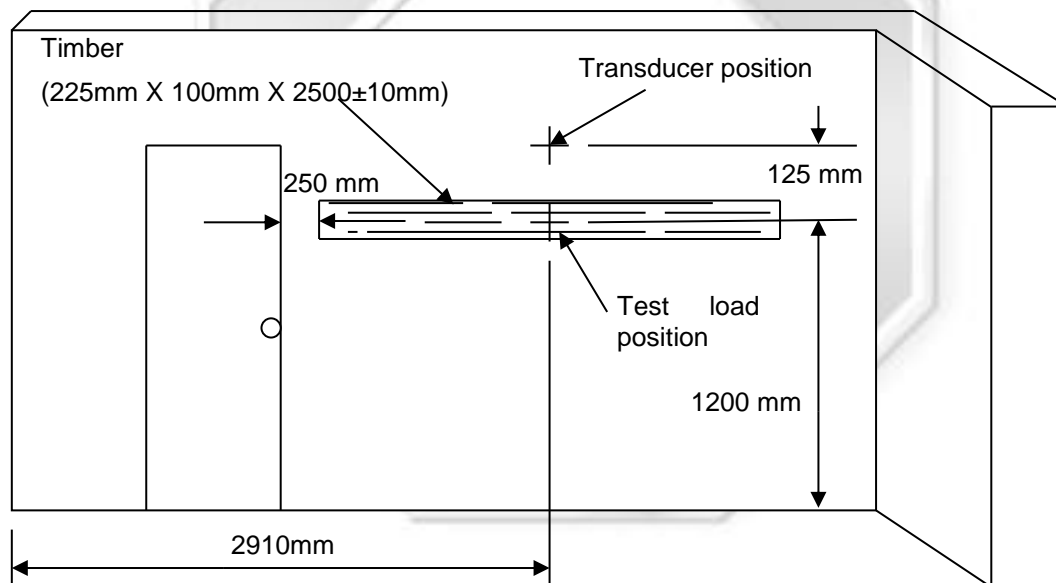
Figure 13: Locations of applied load for crowd pressure

Load	Duration (min)	Deflection (mm)	Residual Deflection (mm)	Condition of the specimen tested	BS 5234: Pt 2: 1992 Requirements
Pretest load of 200 (N)	1	0	0	Hair line crack is observed at the back.	There shall be no collapse or damage that would render the partition wall dangerous, due to any of its parts becoming dislodged or shattered, in a manner that could cause injury.
0.75 kN/m	2	0.10	-		
1.5 kN/m	2	0.41	-		
3.0 kN/m	2	0.79	0.58

A test load of 3.0 kN/m was applied through a 2.5 m long wooden beam placed at a height of 1.2 m above the bottom of the wall. Deflection was taken at 125 mm above the beam. Residual deflection was taken after 5 minutes upon released of the load.

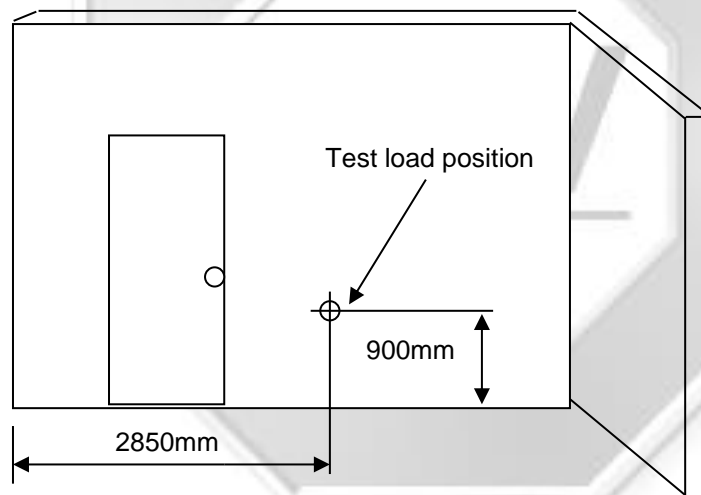
Figure 14: Locations of applied load for lightweight anchorage Pull-out test

Load (N)	Duration (min)	Condition of the specimen tested	BS 5234: Pt 2: 1992 Requirements
100	1	Passed	The partition wall shall withstand the axial load without releasing the pull-up shim plate or damaging the partition other than superficial cracking

A pull-out load of 100 N (± 3 N) perpendicular to the wall was applied on the bracket. The load was held for 1 minute before releasing.

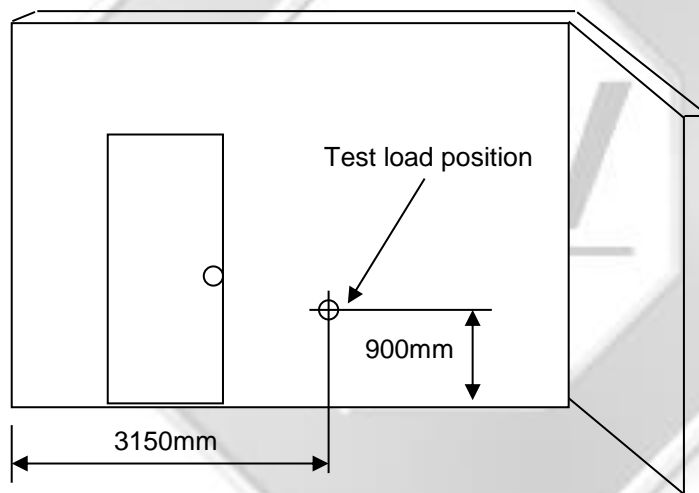
Figure 15: Locations of applied load for lightweight anchorage Pull-down test

Load (N)	Duration (min)	Deflection (mm)	Condition of the specimen tested	BS 5234: Pt 2: 1992 Requirements
250	1	0.00	Passed (No damage occurred)	1) The partition wall shall withstand the tranverse load without releasing the pull-up shim plate or damaging the partition other than superficial cracking. 2) The maximum movement of the pull-down bracket shall not exceed 2mm.

A pull-down load of 250 N (± 7.5 N) parallel to the wall was applied on the bracket. The load was held for 1 minute before releasing.

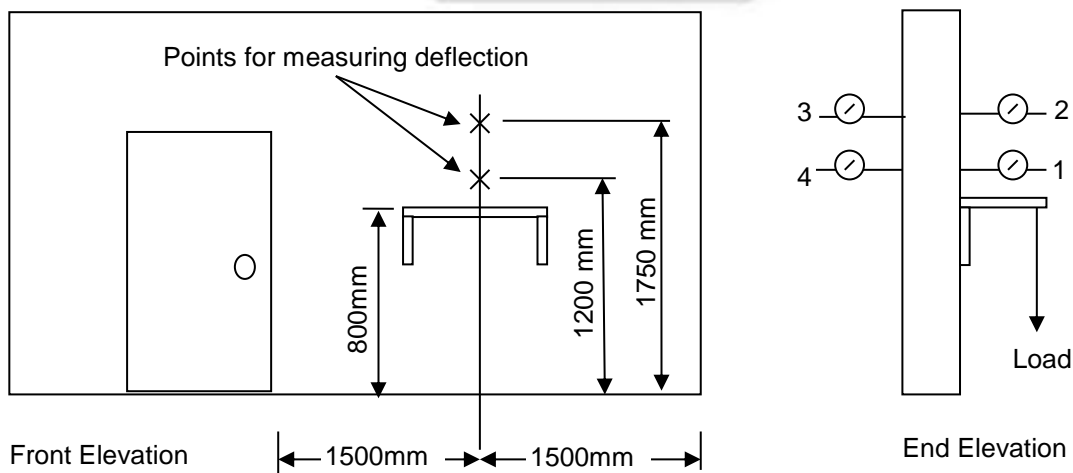
Figure 16: Locations of applied load for heavyweight anchorage
(Wash Basin) eccentric downward loading test

Load (N)	Time (min)	Deflection (mm)				Residual deflection (mm)				Condition of the specimen tested
		1	2	3	4	1	2	3	4	
Pretest load of 200	1	0.01	0.00	0.00	0.00	0.00	0.00	0.00	0.00	No releasing of shim plate No loosening, detaching, or damage to the partition
500	1	0.01	0.00	0.00	0.00	-	-	-	-	
750	1	0.01	0.00	0.00	0.00	-	-	-	-	
500	1	0.00	0.02	0.00	0.04	-	-	-	-	
750	1	0.00	0.00	0.00	0.00	-	-	-	-	
500	1	0.01	0.01	0.00	0.01	-	-	-	-	
1000	1	0.00	0.00	0.00	0.00	-	-	-	-	
500	1	0.00	0.02	0.00	0.02	-	-	-	-	
1000	1	0.01	0.00	0.00	0.00	-	-	-	-	
500	1	0.00	0.01	0.00	0.00	-	-	-	-	
1250	1	0.00	0.00	0.00	0.01	-	-	-	-	
500	1	0.00	0.03	0.00	0.00	-	-	-	-	
1250	1	0.01	0.00	0.00	0.00	-	-	-	-	
500	1	0.01	0.04	0.00	0.02	-	-	-	-	
1500	1	0.00	0.00	0.00	0.00	-	-	-	-	
500	1	0.00	0.07	0.00	0.01	-	-	-	-	
1500	1	0.00	0.00	0.00	0.00	-	-	-	-	
500	1	0.00	0.08	0.00	0.00	0.00	0.00	0.00	0.00

The anchorages shall be capable of withstanding the load selected applied to the 2 linked brackets without releasing either pull-up shim plate, exceeding 20 mm deflection or 1 mm residual deformation limits and without loosening, detaching or damaging the partition wall.

A steel bracket identical to a standard wash basin was mounted at a height of 0.8 m (± 10 mm). Four deflections were taken, two on each side of the wall, at a height of 1.2 m and 1.75 m from the base of the wall. Shim plates were inserted in between the bracket and wall and loaded with a force of 20 N.

Cyclic load of the following sequence was applied: 500, 750, 500, 750, 500, 1000, 500, 1000, 500, 1250, 500, 1250, 500, 1500, 500, 1500 & 500 N. Residual deflections were taken after 5 minutes from unloading.

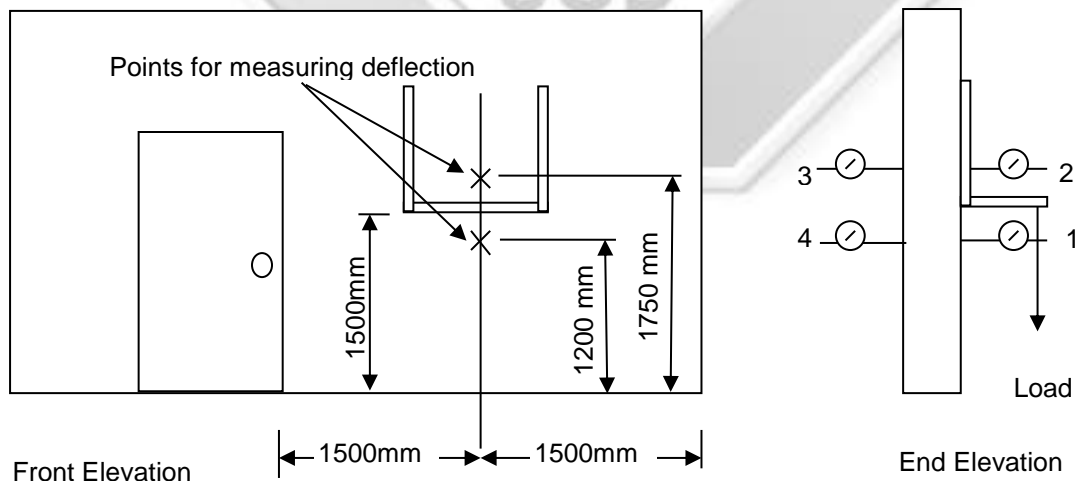
Figure 17: Locations of applied load for heavyweight anchorage (High level wall cupboard) eccentric downward loading test

Load (N)	Time (Min)	Deflection (mm)				Residual deflection (mm)				Condition of the specimen tested
		1	2	3	4	1	2	3	4	
Pretest load of 200	1	0.00	0.00	0.00	0.00	0.00	0.06	0.00	0.00	No releasing of shim plate
500	1	0.00	0.00	0.00	0.00	-	-	-	-	
1000	1	0.00	0.00	0.00	0.00	-	-	-	-	
1500	1	0.00	0.08	0.00	0.00	-	-	-	-	No loosening, detaching, or damage to the partition
2000	1	0.00	0.00	0.00	0.00	-	-	-	-	
2500	1	0.00	0.05	0.01	0.11	-	-	-	-	
3000	1	0.00	0.00	0.00	0.00	-	-	-	-	
3500	1	0.01	0.05	0.00	0.00	-	-	-	-	
4000	1	0.00	0.01	0.00	0.00	0.00	0.04	0.00	0.05

BS 5234: Pt 2: 1992 Requirements	The anchorages shall be capable of withstanding the load selected applied to the 2 linked brackets without releasing either pull-up shim plate, exceeding 5 mm deflection or 1 mm residual deformation limits and without loosening, detaching or damaging the partition wall.
----------------------------------	--

A steel bracket identical to a standard wall cupboard was mounted at a height of 1.5 m (± 10 mm). Four deflections were taken, two on each side of the wall, at a height of 1.2 m and 1.75 m from the base of the wall. Shim plates were inserted in between the bracket and wall and loaded with a force of 20 N (± 1 N).

Incremental load of the following sequence was applied: 500, 1000, 1500, 2000, 2500, 3000, 3500, 4000 N. Residual deflections were taken after 5 minutes from unloading.

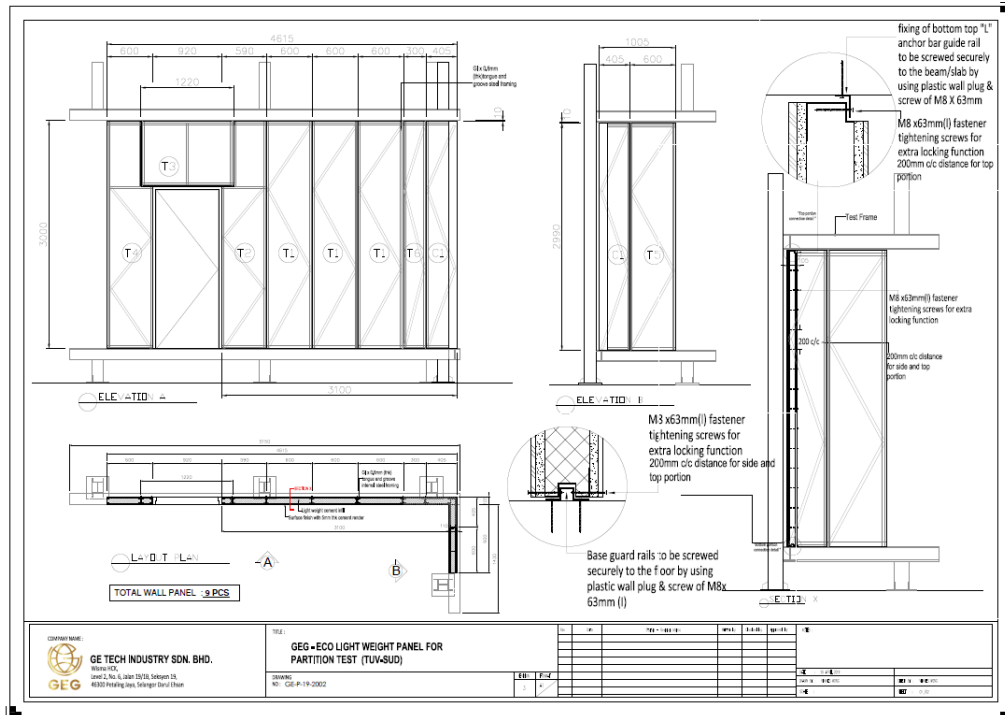
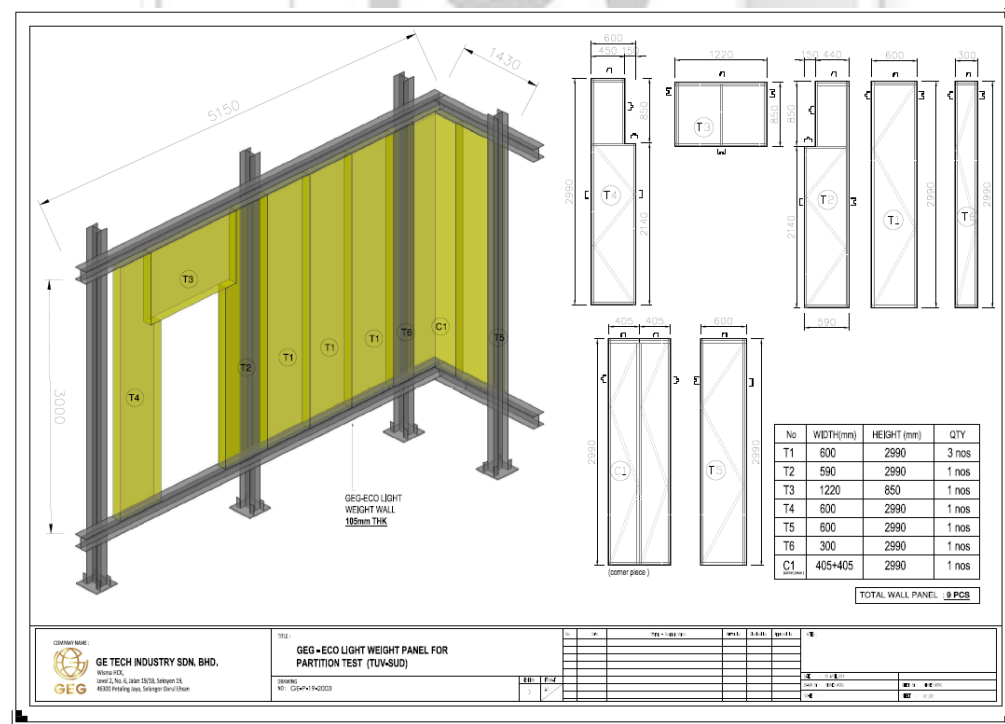
FRONT, RIGHT and ISOMETRIC VIEW

PARTITION WALL DRAWINGS

2. Components used for this system are: - PLEASE REFER TO PARTITION WALL DRAWINGS (Pg. 26)
